MEETING #: 1- **SPECIAL INTEREST GROUPS**
MEETING DATE: January 23 and 24, 2017
PROJECT: Fidalgo Pool and Fitness Center Study
PRESENT: As Noted Below
DISTRIBUTION: Marilyn Stadler
Jeremy McNett
Christine Mathes
Emily Wheeler

Fidalgo Pool and Fitness Center Facility Audit Anacortes, WA

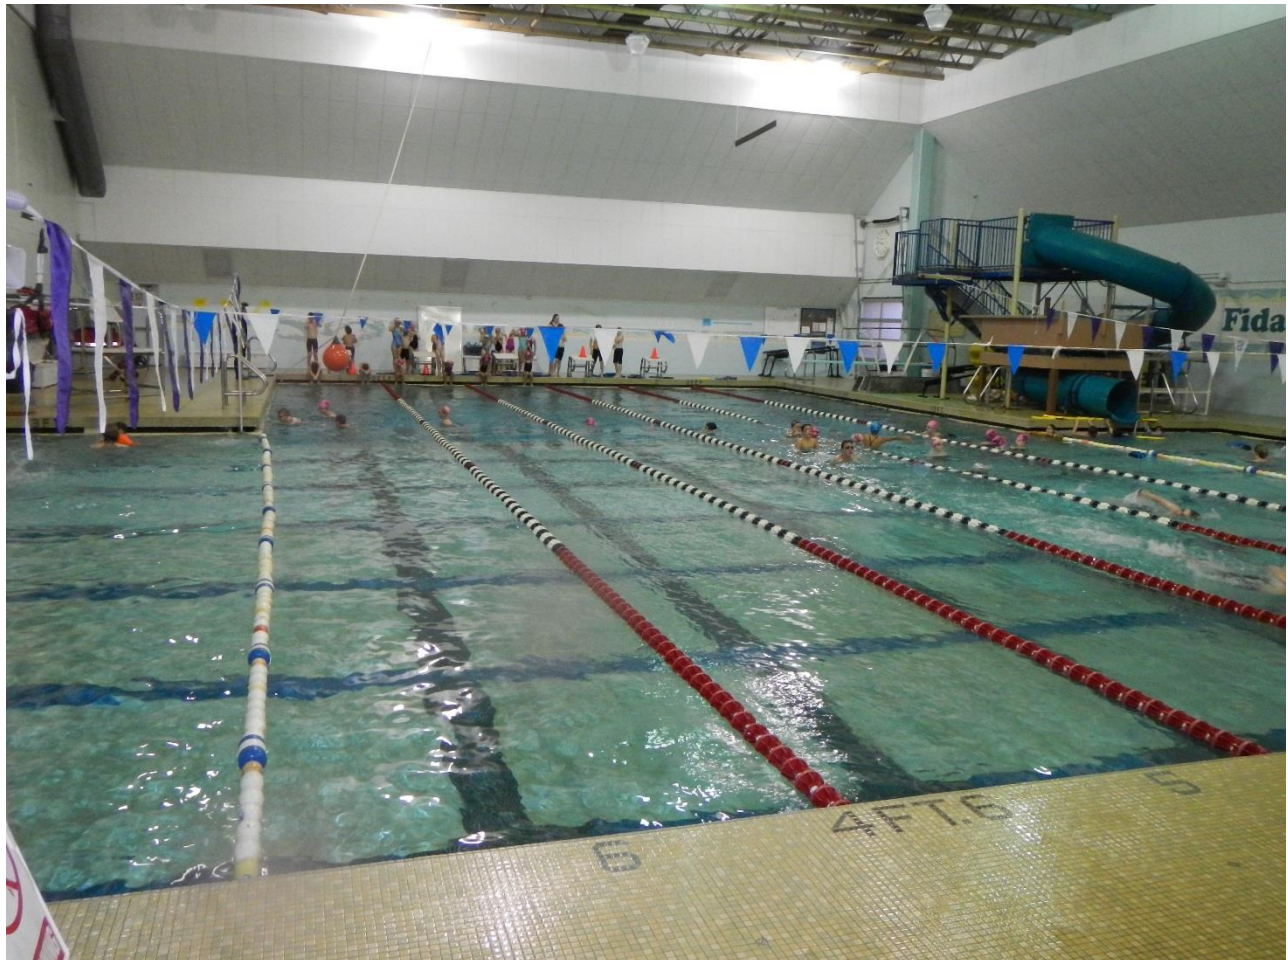
- Facility Opening 1975
- Lap Pool Surface Area: 5,040 sq/ft
- Lap Pool Total Volume: 280,000 gallons
- Flow Rate: 803 GPM
- Turnover: 5.8 Hours

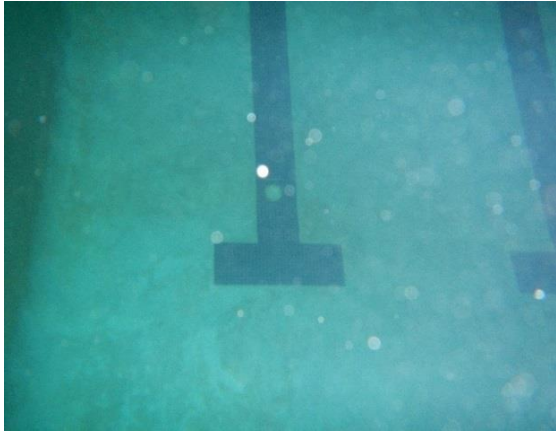
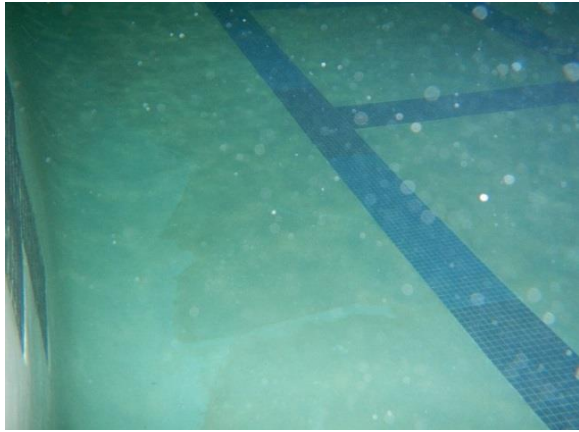
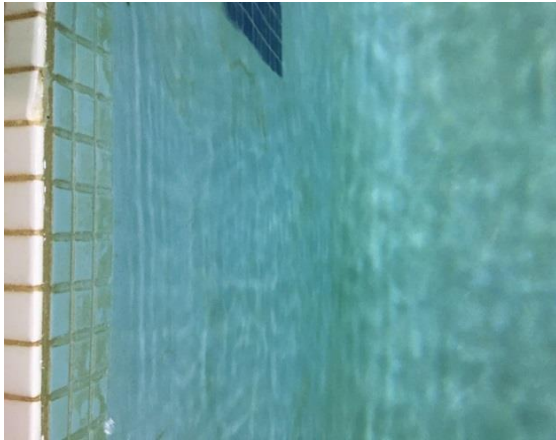
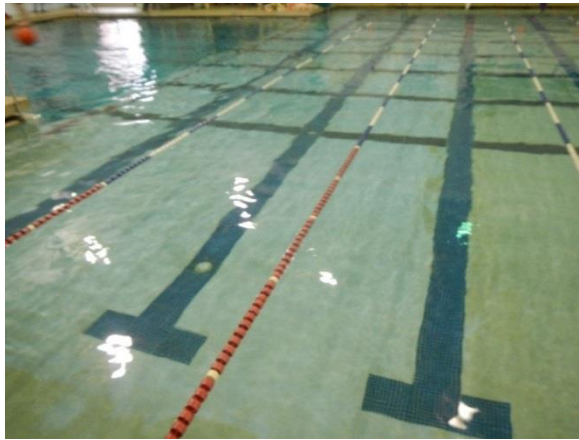
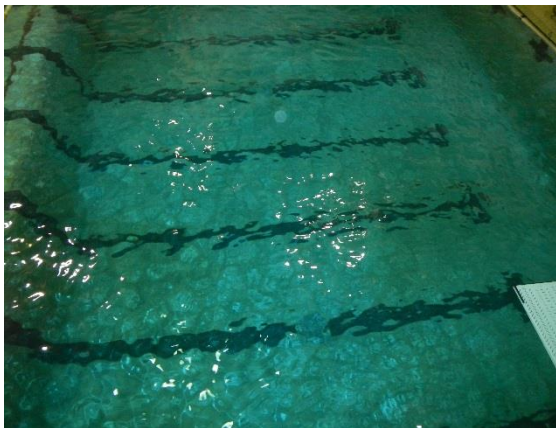
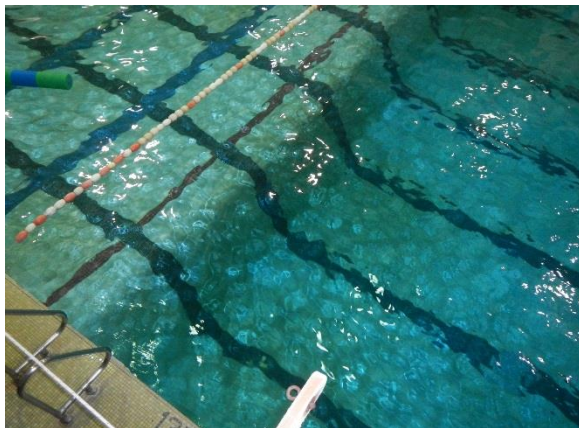
Constructed in 1975, the concrete pool shell is now 42 years old. The plaster pool finish features tile trim, including tile lane markings and wall targets. The gutter is tiled with 1" x 1" tiles, in between the tile pool deck and the plaster pool finish. The existing tile and plaster pool finish shows significant signs of staining, both on the pool floor and on the pool walls. There are also signs of etching of the pool surface.

Staining of the pool surface can be attributed to poor water balance or metals found in the pool water. Fill water which is high in copper or iron must be removed or severe staining can result. Staff should ensure the pool water balance is adequate to prevent scaling and corrosion. Rust colored stains can be a clear indication that the pH of the pool water is out of balance. The low pH levels are typically caused by overfeeding muriatic acid. Corroding of cast iron piping remaining in the system is another potential source for this staining. This is a common issues in indoor pools. The surface can be cleaned when the pool is drained for routine maintenance, but with the extent of the staining a new application of plaster or quartz aggregate surface such as Diamond Brite is recommended.

Staff report that some sources of iron that may have contributed to the pool stains have been removed in the last few years, including a rusted chain fall system and two large iron brackets in the surge tank that supported the pool water fill tube and the pool water level float tube.

The pool floor drops immediately from a depth of 4 feet to a depth of 12 feet. The Washington administrative code as well as the industry standard requires a maximum slope of 1:3 from shallow water to deep water. Assuming a future slope modification occurred at the current 4 foot depth, the slope and depth of the diving well would no longer be in compliance.

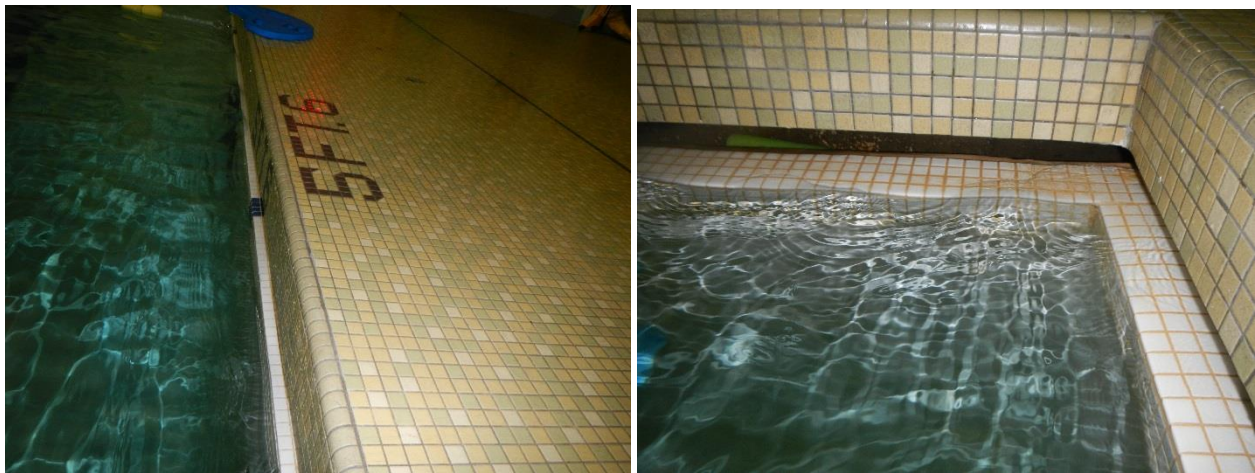
B. Perimeter Overflow System

A fully-recessed gutter with an all-tile finish is provided for surface skimming around the pool perimeter. The gutter system is in fair condition and has noticeable staining of the tile, but very few tiles were observed to have delaminated. The pool gutters drain by gravity to the surge pit through a 10" pipe that can handle up to 672 GPM at 3 ½ ft/sec. This piping is rated to handle 83% of the overall flow for the pool.

The current Washington Administrative Code requires overflow gutters shall be capable of continuously removing no less than 100% of the recirculated water, which is not met with the current flow rate and gutter capacity. The ability for the gutters to be able to handle 100% of the pool's flow is generally recommended and an industry design standard.

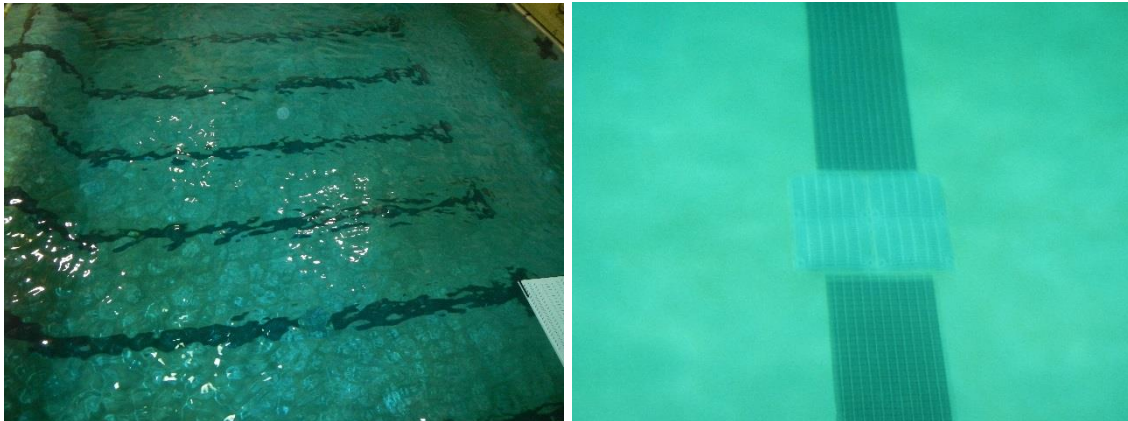
C. Main Drains

There are two (2) 24" x 24" square, fiberglass main drain covers located in the deep part of the competition pool. The main drains appear to have secured grate covers that are suction and hair entrapment certified as required by the Virginia Graeme Baker Pool and Spa Safety Act (VGB), ASME/ANSI A112.19.81.

All main drains with dimensions 18" x 23" or smaller are classified as "blockable" and must have a VGB stamped and certified "unblockable" grate cover with tamper proof screws. The federal regulations of VGB were passed by Congress in 2008 and are designed to reduce the potential for suction and hair entrapment in commercial swimming pools at all suction outlets (e.g. main drains, skimmer equalizer lines, etc.). The Consumer Product Safety Commission (CPSC) is tasked with federally enforcing all VGB regulations, but due to the vast number of commercial swimming pools in the United States, enforcement most commonly is the responsibility of the local governing agencies (e.g. public health departments, building departments, etc.).

Staff report that the main drain is gravity-fed. It is routed to a single 10in pipes that is rated 672 GPM at 3 ½ feet per second. The CH standard is for the main drain piping to be rated to handle 100% of the circulation, which is not met by the single 10" pipe at the observed flow rate of 803 GPM.

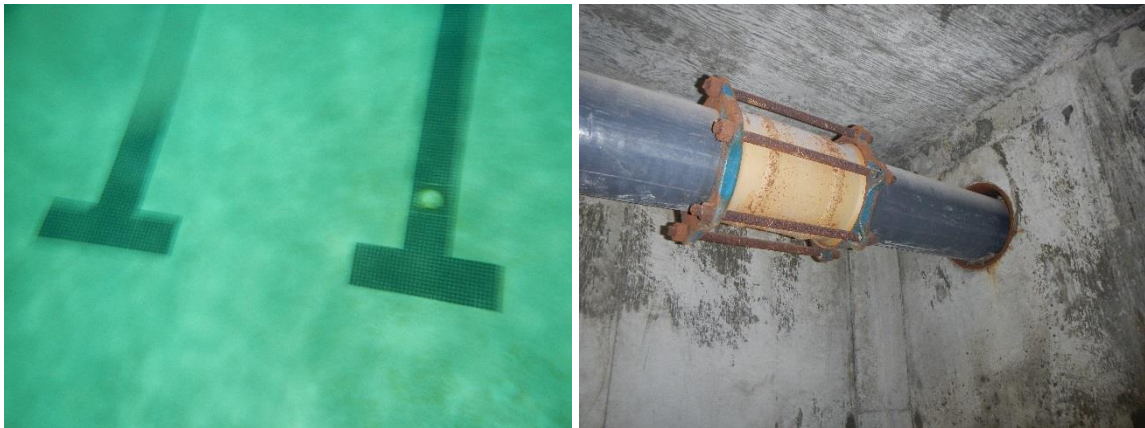
D. Inlets

The pool is equipped with 12 floor inlets in the shallow end and 6 floor inlets in the deep end. The inlets are fed with a 8" supply line that is rated for up to 812 GPM at 8 feet per second and 975 GPM at 10 feet per second. The flow rate of 803 GPM falls within the rating for the current piping.

Of the two inlet systems (floor and wall), the floor inlets are usually recommended over wall inlet systems for larger pools. The reason is that a relatively equidistant location of the floor inlets provides a more uniform distribution of filtered water over the floor. This situation affects, in a positive way, the subsurface turbulence created by the swimmers overhead. The floor system also provides a "sweep and clean" movement of the water across the pool floor, picking up small dirt and debris.

The Washington Administrative Code requires inlets to be located on the bottom of swimming and wading pools over twenty-five hundred square feet and spa pools greater than ten thousand gallons. The current inlets meet this requirement.

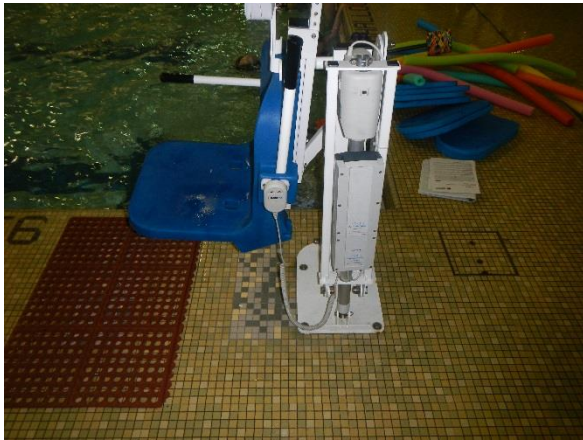
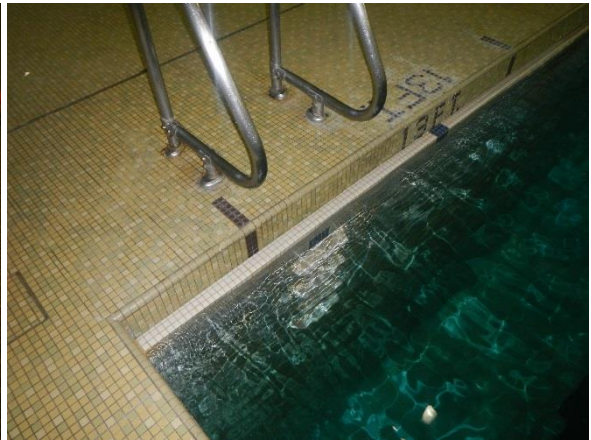
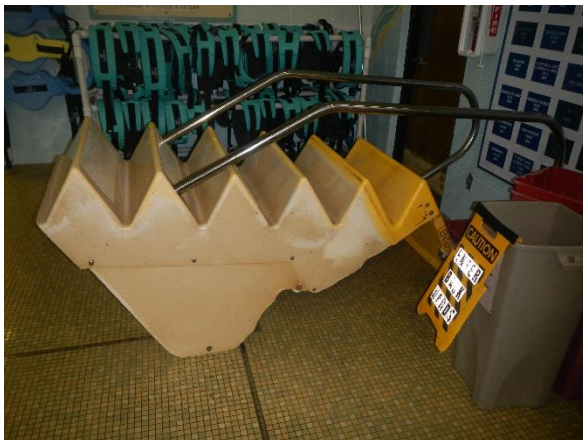
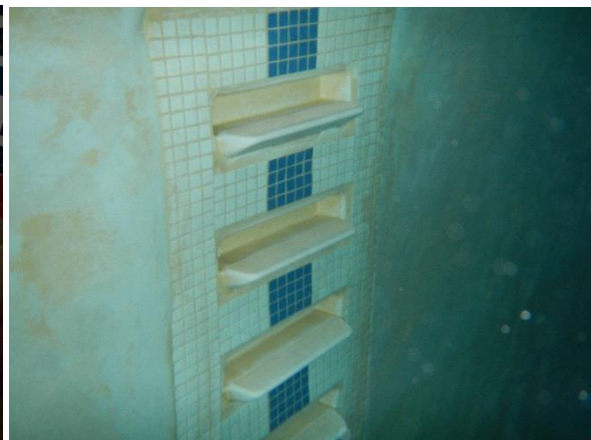
E. Ingress and Egress

The pool has deck-anchored stainless steel grab rails with embedded steps located around the pool perimeter in the wall. A compliant Americans with Disabilities Act accessible means of entry is provided for the pool. The ADA Act requires that a swimming pool with a perimeter that is more than 300' have at least two accessible means of entry and requires accessible lifts to be capable of unassisted operation from both the deck and water levels. Controls and operating mechanisms shall be unobstructed when the lift is in use.

The pool also has two fiberglass stairs with stainless steel grab rails as an alternative means of entry and exit for the pool. The handrails on the stairs are 27" apart and do not comply with the ADA standard 109.6.2 Handrails, which stipulates handrails must be within 20" and 24".

"109.6.2 Handrails. The width between handrails shall be 20" (510 mm) minimum and 24" (610 mm) maximum. Handrail extensions required by 505.10.3 shall not be required on pool stairs."

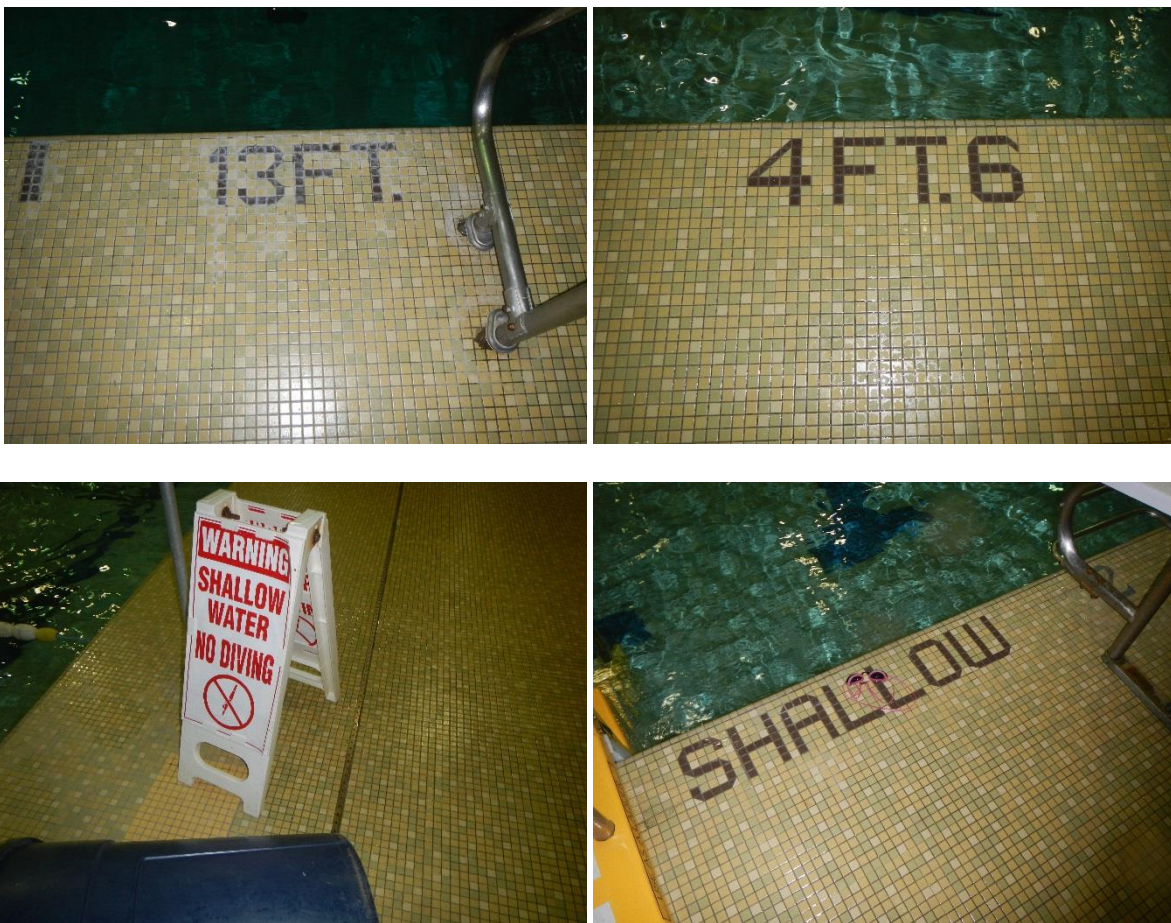
F. Depth Markings and Warning Signage

Tile horizontal depth markings are located on the tile deck around the perimeter of the pool, and inside the gutters below the deck. The deck tile markings are 7 inches tall while the gutter tile markings are 5 inches tall. This meets the Washington State Code requirement that depth markings should be “Located on the horizontal surface of pool coping or deck of pools within eighteen inches of the water's edge, easily readable while standing on the deck facing the water, in numbers at least four inches high.”

The measurements of the pool depth markings are off by roughly 2 inches. Staff reports the gutter lip was raised by two inches several years ago, but the depth markings were never adjusted to reflect the new depth.

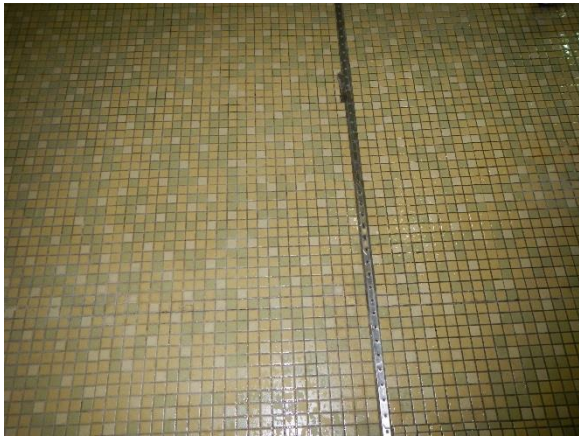
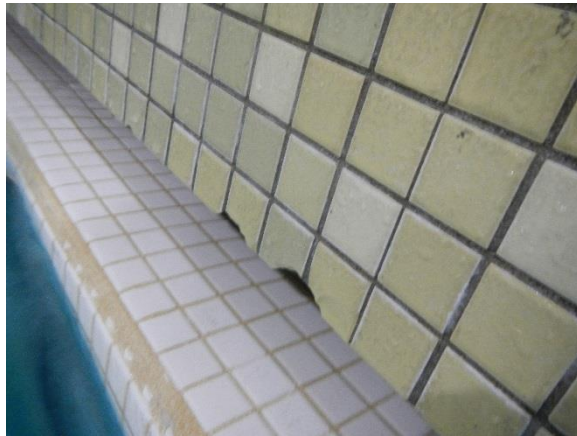
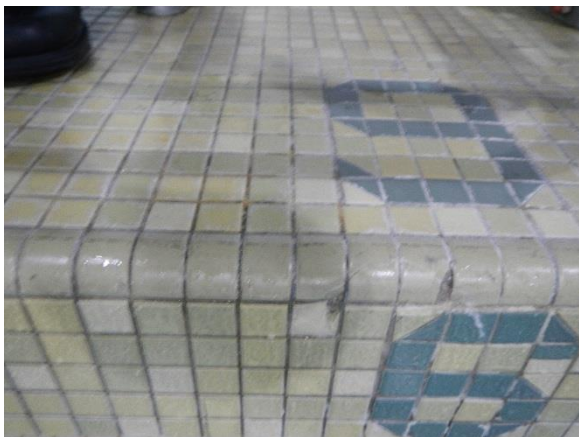
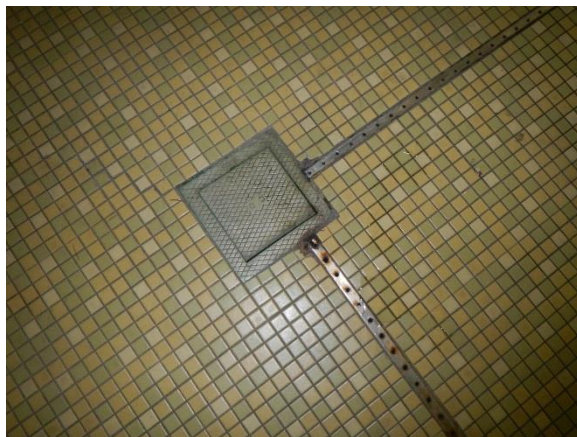
The pool deck is in fair condition with minimal observable cracks. The perimeter trench drain appears to be working effectively as standing water was not observed at the time of the site visit. There were areas of the deck/tile gutter connection that had sharp edges that could cause injury to pool guests, as well as a few areas where the tile had been chipped or in some instances popped off.

“For pools fifteen hundred square feet or larger, walking deck surfaces must be at least six feet wide:

- (i) Around the entire perimeter of outdoor pools;
- (ii) On fifty percent of the perimeter of indoor pools; and
- (iii) The remaining fifty percent perimeter of the indoor pool must be a minimum of four feet wide.”

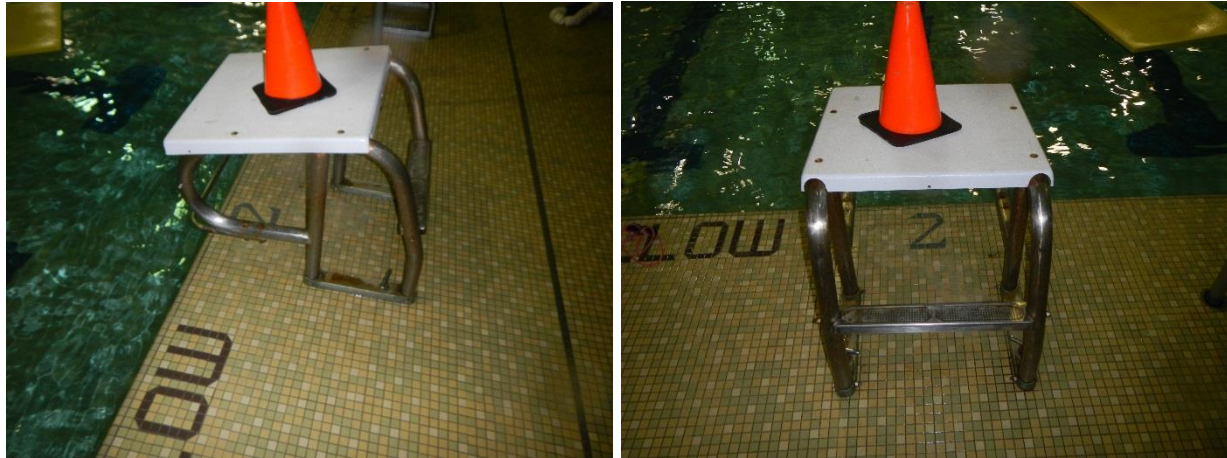
B. Starting Blocks

The pool has nine (9) starting blocks that are interchangeable and moved in between the shallow end and deep end of the pool, depending on the course length used by the competitive swim teams. This depth requirement meets the National Federation of High School Swimming (NFHS) requirement of a 4 foot minimum depth of water and that the blocks are a maximum of 30 inches above the surface of the water.

The starting blocks are an older model that does not meet the current expectations for competitive swimming. Today's industry standard for starting blocks includes dimensions of 24" x 32" for the platform. The current blocks are 22 x 22 which is close to the minimum standard for starting blocks.

These blocks meet the Washington State Code that requires protective equipment when not in use. "If water depth is less than nine feet, starting blocks must be removed or covered with protective equipment unless used by competitive swimmers trained in proper use of starting blocks."

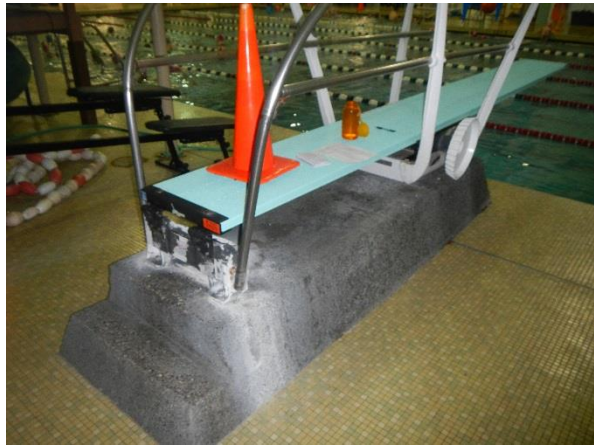
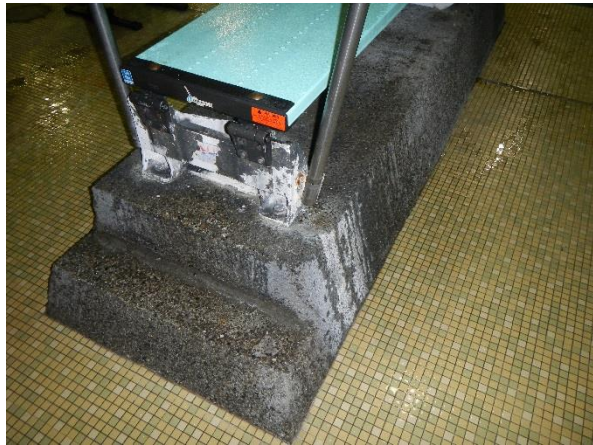
C. Diving Boards

A single 1-meter diving board is provided. The board is mounted on a concrete pedestal and is in good condition. When comparing the existing diving well dimensions to the dimensional requirements of NFHS, FINA and the NCAA, the following items were observed: (diagrams illustrating these items are found below)

The pool meets the current 1-meter depth/slope requirement for NCAA, FINA and High School.

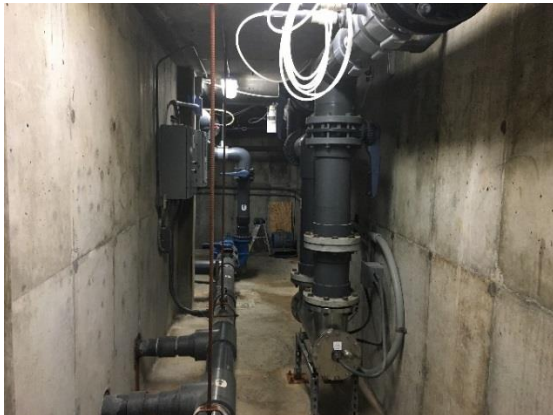
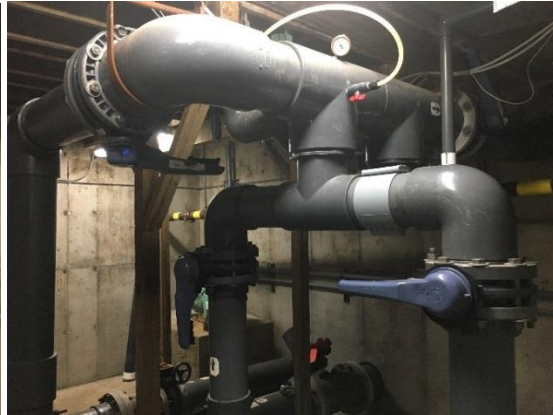
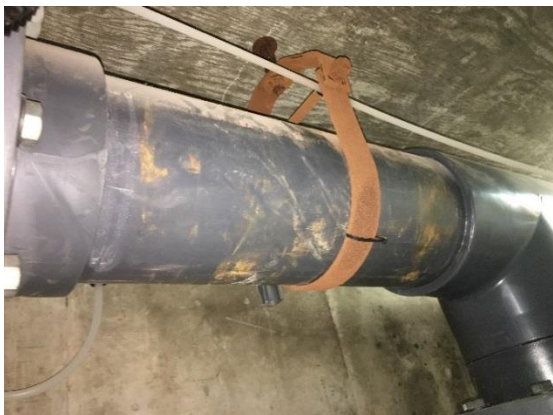
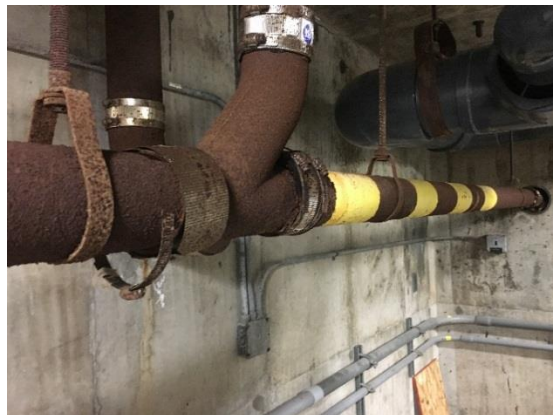
The visible, above ground recirculation piping for the pool in the pool mechanical room is Schedule 80 PVC piping, which is in good condition. The visible piping in the mechanical room leading to and exiting the pool is Schedule 80 PVC and staff report the gutter drain pipe is PVC for several feet before turning at a PVC elbow. Corrosion is noticeable at some of the pipe connections both the bolts and the valves, but overall the majority of piping and connections are in good condition. There is visible corrosion on several of the pipe supports throughout the mechanical room, and the pipe from the sanitary drain system has significant corrosion. Directional arrows are provided on the exposed piping as per industry standards. The valves in the mechanical room have been replaced as necessary. Several of the overhead pipe supports show significant signs of corrosion.

With a pool of this age it is not uncommon that some of the underground piping has corroded to the point of failure. The corrosion build up on the interior of the pipes also impact pipe velocities and could be contributing to the pool surface staining. A camera test could be done to determine the integrity of the piping.

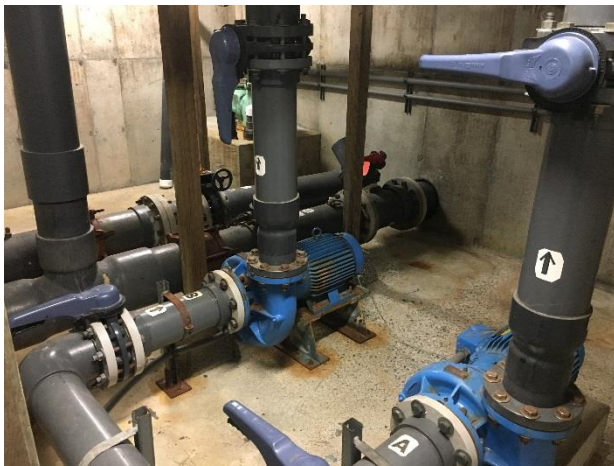
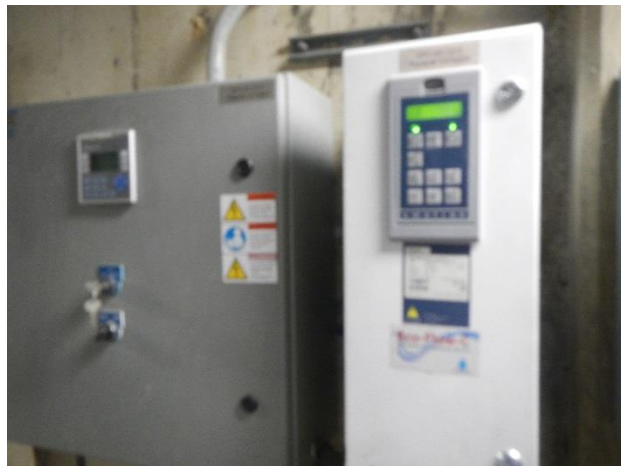
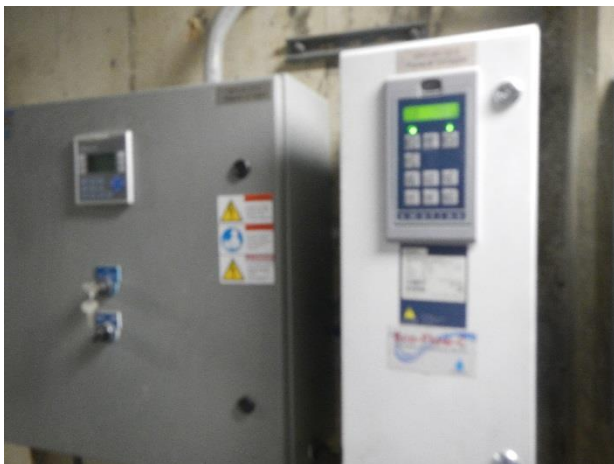
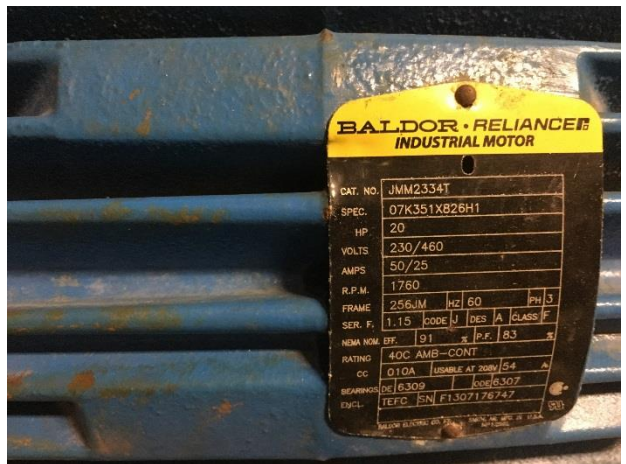
B. Pump

Both pumps and motors have been recently replaced and are alternately used on a monthly basis. They do have visible signs of corrosion, but appear to be in good condition. The recirculation pump is fed by a 20 horsepower motor. A strainer is provided for the pump as required by the administrative code. The GPM rating for the pump was not verified by nameplate during the site visit.

The pump impeller should be statically and dynamically balanced and trimmed for the specified design condition. A coating system to protect the pump cast iron from corrosion is an industry standard on all non-bronze pumps. Staff should confirm the impellers are coated to ensure their expected lifespan.

A variable frequency drive is installed on the circulation system, model Eco-Flow-C. A variable-frequency drive (VFD) is a system for controlling the rotational speed of an alternating current (AC) electric motor by controlling the frequency of the electrical power supplied to the motor. Staff report the VFD was installed in 2014 and it is operating correctly at this time.

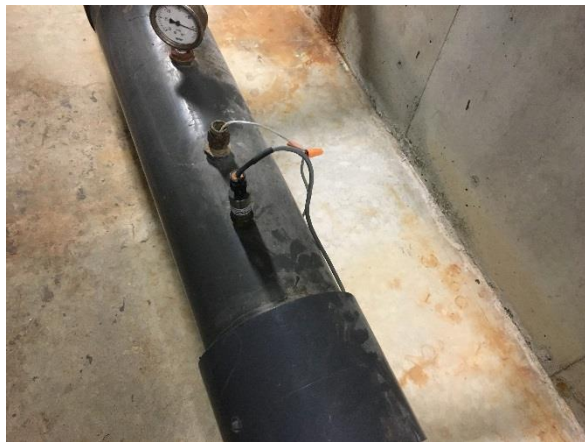
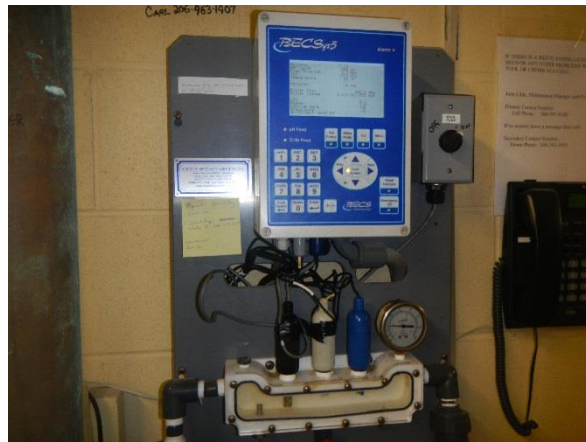
C. Flow Meter

There are two flow meters installed on the pool, one is an acrylic flow meter and is installed on the pressure piping back to the pool, downstream from the filter, which is the preferred place for mounting. The other is tied directly into the BecSys chemical controller. Flow sensors should be installed with at least ten pipe diameters downstream and five pipe diameters upstream on a straight run of piping.

The flow meter was giving a reading of 803 GPM which places the turnover at 5.8 hours. According to the Washington State Code, "Owners of swimming pools shall design and maintain water treatment recirculation rates to completely turn over the entire pool water volume of pool in six hours or less." The Fidalgo Pool meets this requirement.

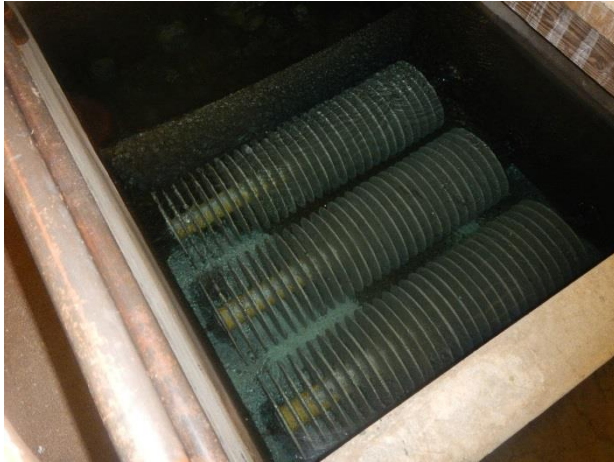
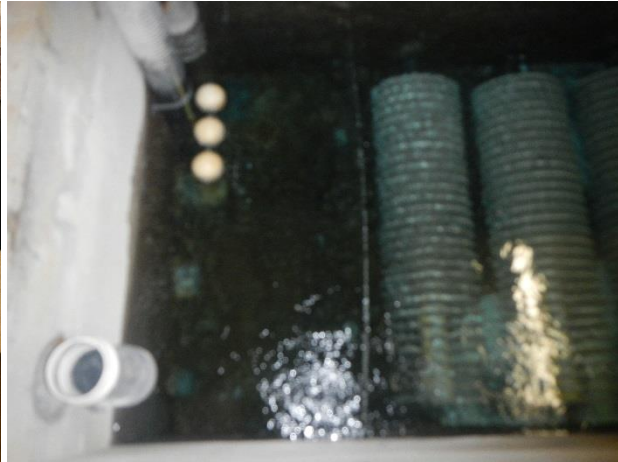
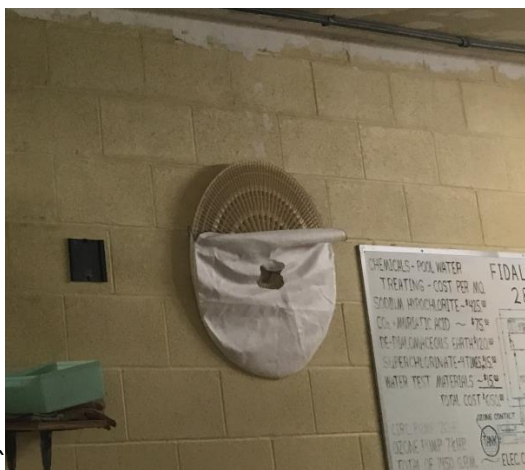
D. Filtration System / Surge Tank

The pool uses open-air vacuum Diatomaceous earth (DE) filters for its filtration. This system was installed during the initial construction. While these filters have served the facility well and provided ample water quality over the years, it is an antiquated system and should be replaced during a facility renovation with either high-rate sand filtration or regenerative media filtration.

The size and capacity of these filters could not be verified by nameplate on site during the audit, but staff notes have estimated each disc at 26 inches of diameter, equaling 121 SF of total surface area. The standard flow rate for this type of filtration system is to stay within 1 to 3 GPM/SF of surface area. With a flow rate of 803 GPM, the filtration rate is calculated at 6.6 GPM/SF which exceeds the industry standard for this type of filter by more than double.

Washington State Code requires the capacity in gallons of the surge tank to equal the square footage of the pool. This would require the surge tank to hold 5,040 gallons.

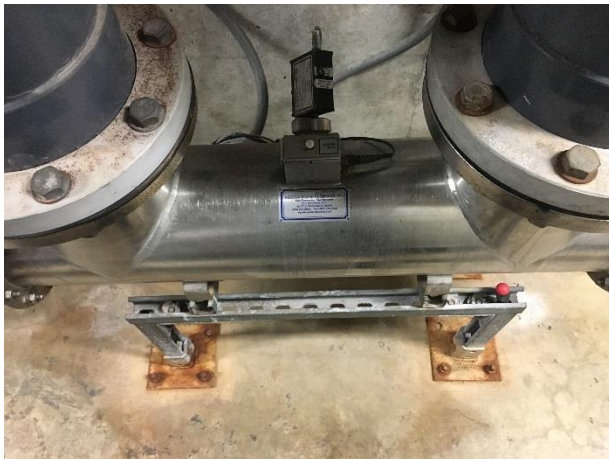
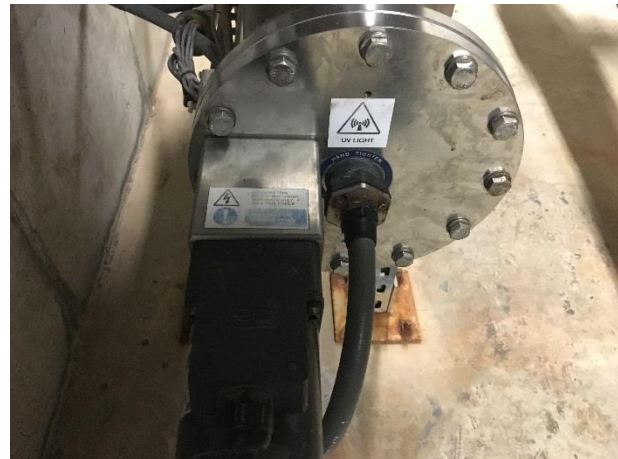
E. UV System

The pool mechanical system contains a Hanovia Ultraviolet Light Water Treatment System (UV). UV becomes beneficial in water treatment applications due to its ability to eliminate combined chlorine (also known as “chloramines”) and kill chlorine resistant pathogens. While UV does break down free chlorine, the good form of chlorine used for pool disinfection, it is still highly recommended due to its ability to eliminate chloramines. Lower levels of chloramines lessens the corrosive off-gassing which attributes to the corrosion of deck equipment, HVAC, and internal structures of some facilities. Additionally, chloramines are typically responsible for the odor and irritation experienced by athletes, coaches and staff.

Eliminating chloramines creates a healthier and more enjoyable environment for facility users and staff. A UV system should be included in any future mechanical system renovations, or the construction of a new aquatic facility. Not only will UV systems kill pathogens and chloramines, but they will also eventually provide cost savings. It is common for a UV units to help lengthen and enhance the life expectancy of building materials, dehumidification units, etc. due to the elimination of combined chlorine before it is released into the air and causes corrosion of these materials.

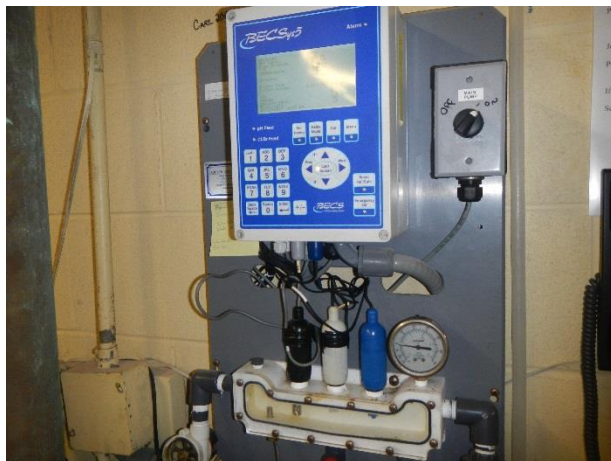
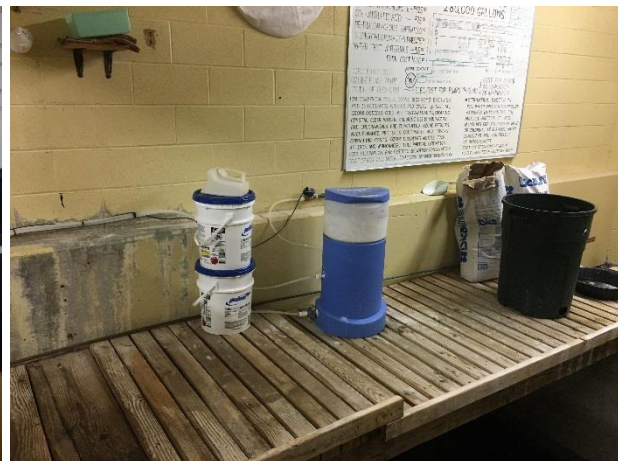
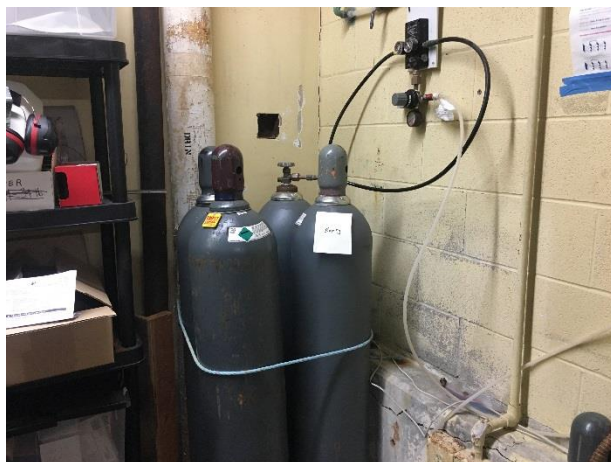
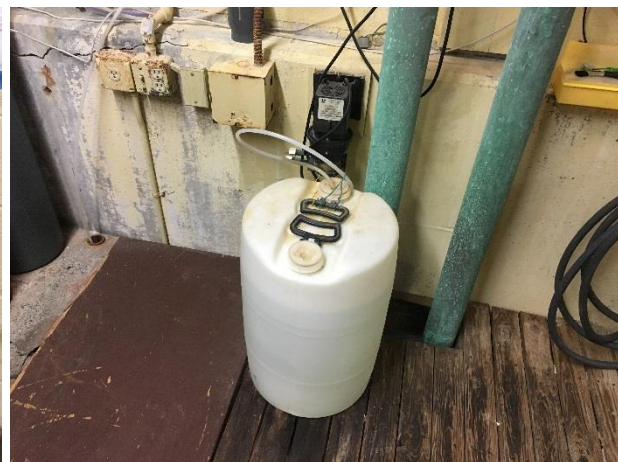
F. Chemical Treatment System

Currently the pool chemicals are located in the same area as the pool mechanical room. The pool is sanitized with Calcium hypochlorite (tablet chlorine) through a Pulsar 3 system and both CO2 and muriatic acid are used as the pH buffer. The 50 lb. buckets of calcium hypochlorite are stored inside the pool mechanical room on a platform above the surge tank. The muriatic acid and CO2 are stored in the same area, next to the chemical controller.

According to the Washington State Code, "Owners shall provide a separate chemical storage area or room that conforms to manufacturer's requirements for each chemical used in the pool area." A separate dedicated and ventilated chemical storage room for both the sanitizer and pH buffer is recommended and is the current industry standard. The existing chemical storage area does not meet the current requirement or standard. Dedicated chemical storage spaces should be included in any future plans, whether for a renovation or a new facility.

The pool is controlled by a BecSys 5 chemical controller. The chemical controller automatically adds chlorine and the pH buffer, maintaining the proper chemical balance throughout each day. The controller is in good working condition and is appropriate for this type of usage.

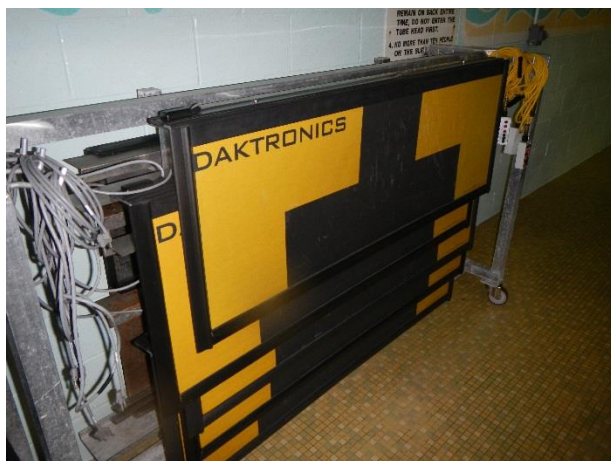
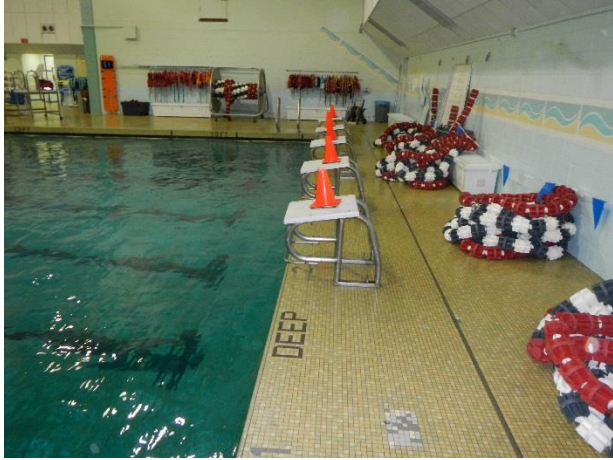
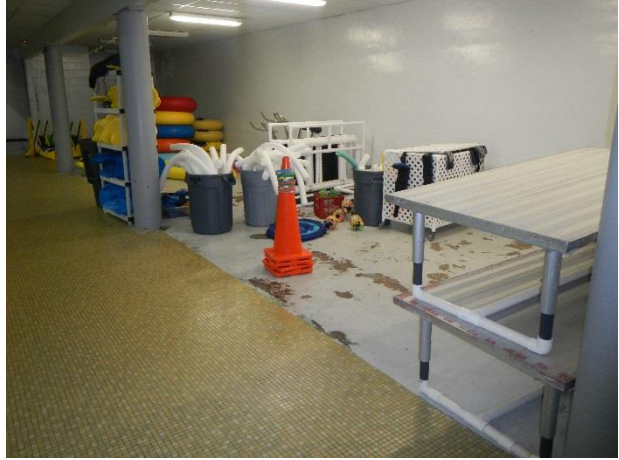
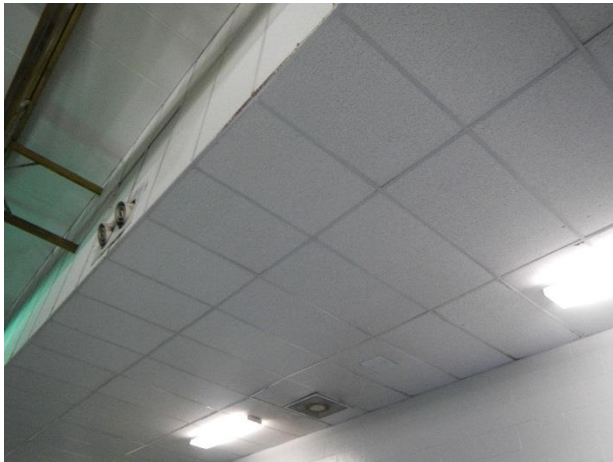
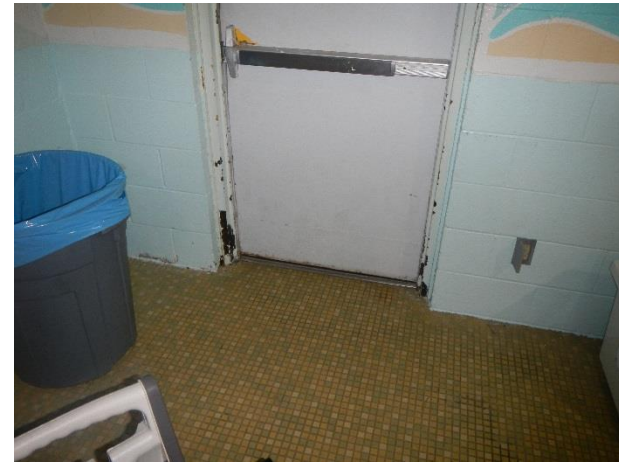
G. General Observations

- There is not enough storage space at the Fidalgo Pool and Fitness Center. Currently the pool deck is used for storage for items such as the Daktronics timing equipment, lane ropes for the 25 meter course length, and swim lesson equipment (such as kickboards, floats and underwater benches).

- The first two rows in the upstairs spectator seating for the swimming pool are not able to see the first two lanes during swim meets.
- Staff report that 60% of the ceiling material in the Fidalgo Pool has been renewed within the last 5 years with the entire south and east walls being new. Ceiling panels in a natatorium are usually made of galvanized steel with a coating of high-build epoxy coating. Other materials can be precast concrete, wood or aluminum. As with other materials in a natatorium, acoustical wall and ceiling must be corrosion resistant and interface with a vapor barrier, if necessary.

- User groups reported the air quality in the second-level spectator seating area is poor. Spectator areas should have higher air velocities of cool air (40 ft/min to 50 ft/min). Ceiling fans have also been used to improve spectator comfort. High velocity warm air in the face of spectators can be uncomfortable; therefore, cool air should be introduced over any raised spectator gallery for a major venue facility.

- Significant corrosion exists around the door frame on the east wall of the natatorium.
